# Manhole Inspection Summary

Manhole # S31S1\_028MH

Printed On: 10/15/2008

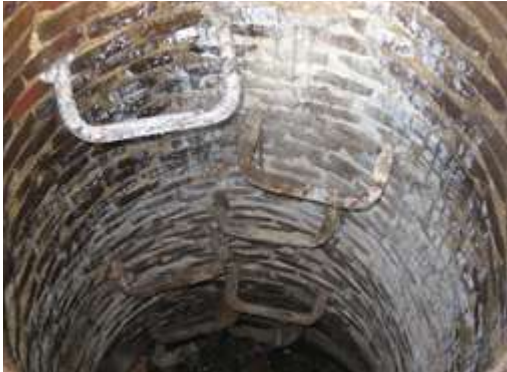
Steps

**Steps** Count: **9** Missing: **1** ☒ **Corroded**

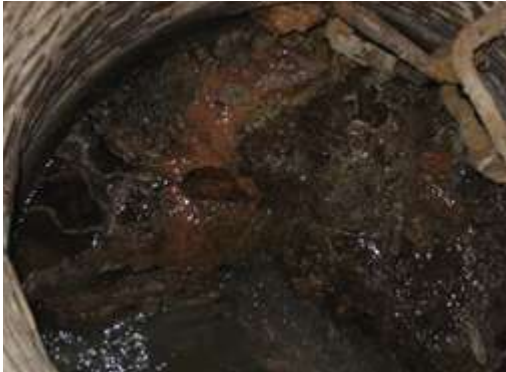
Defect 2

Condition: ☐ Sound ☒ **Cracked** ☐ Root Intrusion ☒ **Deteriorated** ☒ **Leaks** ☒ **Debris**

Bench

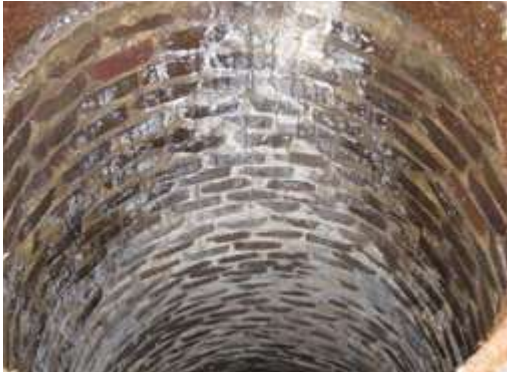
Defect 1

Infiltration: ☐ None ☐ Joint ☐ Cracks ☐ Mortar ☐ Roots ☒ **Wall**

Wall

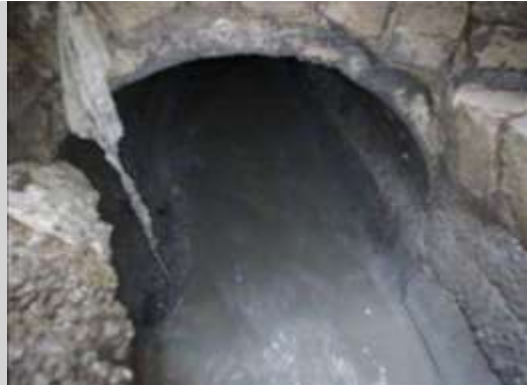
12 O'Clock Outflow

15 in. Circular Gravity Sewer  
Pipe Out @ 12 O'Clock

Pipe Height: **16.8** (in.) Rod and Bar (Angled)  
Pipe Material: **Clay** ☐ Pipe Lined  
Invert Depth: **13.97** (ft.) Flow Characteristics: **Fast**  
Deposits: ☒ None ☐ Mud ☐ Sludge ☐ Debris ☐ Grease  
Silt Depth: (in.) Deposits Extent:  
Infiltration: **None** Pipe Seal Cond: **Sound**

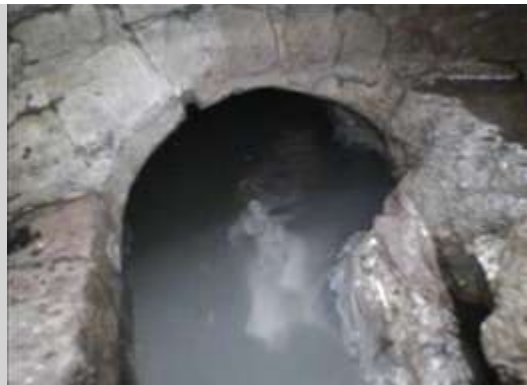
4 O'Clock Inflow

15 in. Circular Gravity Sewer  
Pipe In @ 4 O'Clock

Pipe Height: **15.6** (in.) Rod and Bar (Angled)  
Pipe Material: **Clay** ☐ Pipe Lined  
Invert Depth: **13.85** (ft.) Flow Characteristics: **Fast**  
Deposits: ☒ None ☐ Mud ☐ Sludge ☐ Debris ☐ Grease  
Silt Depth: (in.) Deposits Extent:  
Infiltration: **None** Pipe Seal Cond: **Sound**

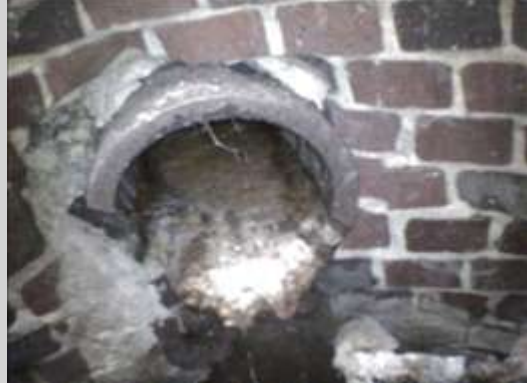
7 O'Clock Inflow

10 in. Circular Gravity Sewer

Pipe In @ 7 O'Clock

Pipe Seal Cond: **Broken**
